UNDERWATER BRIDGE INSPECTION REPORT

STRUCTURE NO. 23501

ROOT RIVER

MINNESOTA DEPARTMENT OF TRANSPORTATION
UNDERWATER BRIDGE INSPECTION

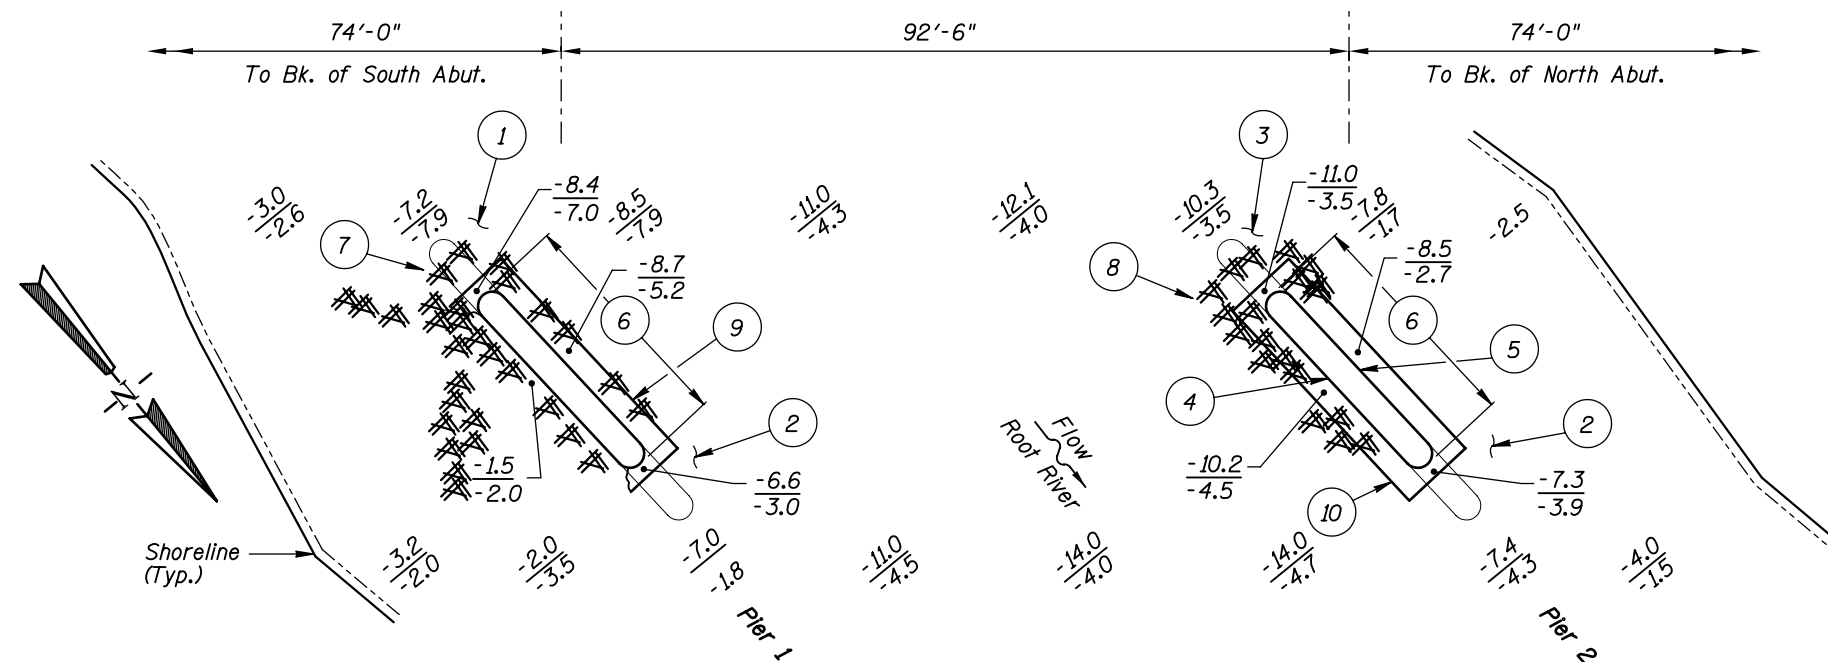
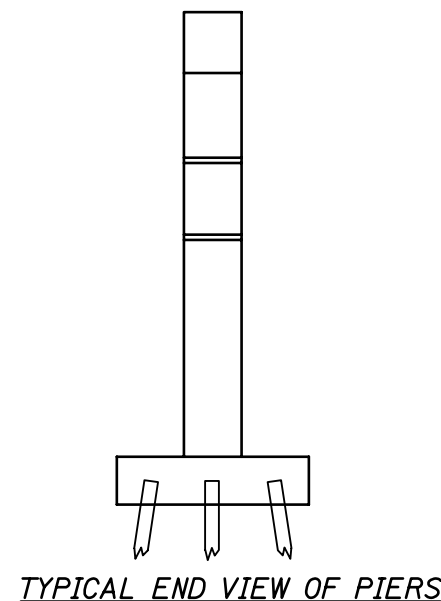
INSPECTION AND SOUNDING PLAN

- 1 The channel bottom consisted of gravel and silt with 2 inches of probe rod penetration.
- 2 The channel bottom consisted of silty sand with up to 1 foot of probe rod penetration.

- 3 The channel bottom consisted of soft silt with up to 3 feet of probe rod penetration.
- 4 A vertical hairline crack was observed at the midpoint of Pier 2 that extended from the top of the pier cap to 2 feet below the waterline.

- 5 A vertical hairline crack was observed at the midpoint of Pier 2 that extended from the top of the pier cap to the top of the footing.
- 6 Light scaling was observed along all pier faces from 1 foot above to 1 foot below the waterline with a maximum penetration of 1/16 inch.

- 7 A heavy accumulation of 1-foot-diameter-and-smaller timber debris was observed extending from the channel bottom to the top of the pier cap at the upstream end and along both faces of Pier 1.

- 8 A moderate to heavy accumulation of 2-foot-diameter-and-smaller timber debris was observed extending from the channel bottom to the top of the pier cap at the upstream end and along both faces of Pier 2.

- 9 Soundings indicate the footing was exposed at Pier 1 at the upstream nose, along the west face, and at the downstream nose with 6 inches of potential undermining along the west face (area inaccessible to diver due to heavy debris).

- 10 The footing was exposed at Pier 2 with undermining and steel H-piles observed from the midpoint along the east face, around the upstream end, and extending to the downstream end with a maximum height of 4 feet at the upstream nose.

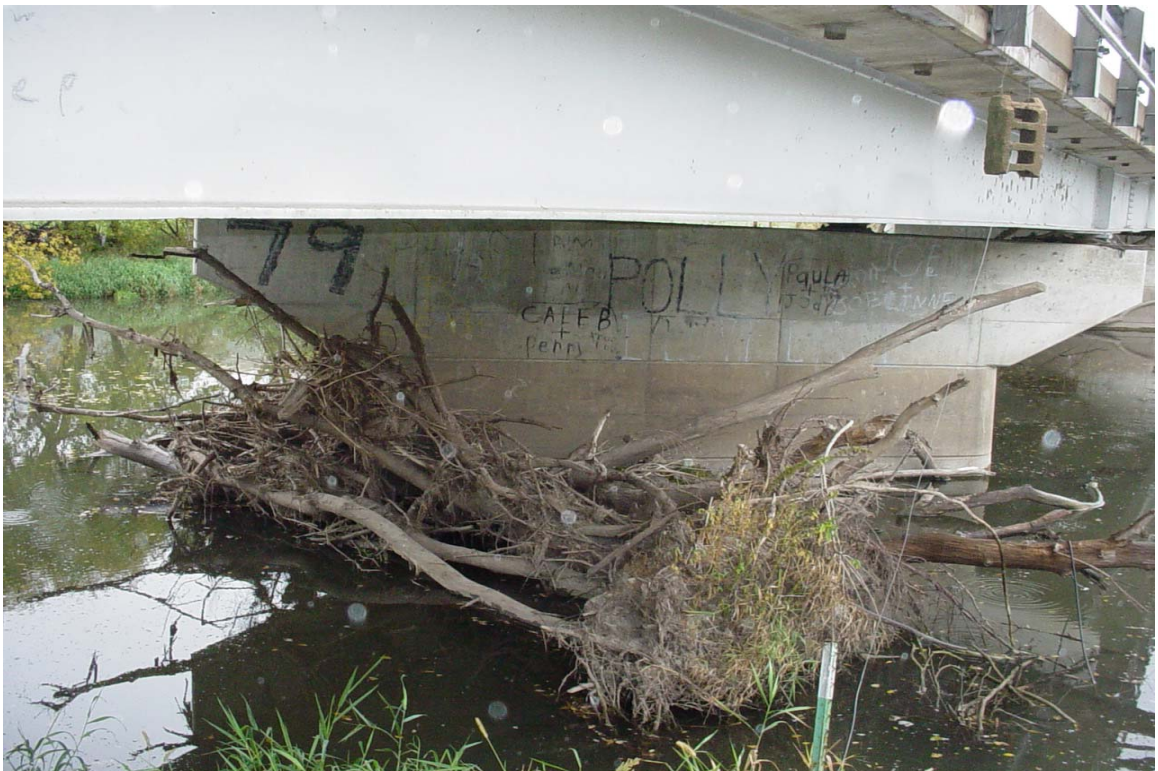
- (A) A heavy accumulation of 1-foot-diameter and smaller timber debris was observed extending from the channel bottom to the top of the pier cap at the upstream end and along both faces of Pier 1. Soundings indicate the footing was exposed at Pier 1 at the upstream nose, along the west face, and at the downstream nose with 6 inches of undermining along the west face, however, the area was inaccessible to the diver and footing exposure or undermining could not be confirmed.

Photograph 2. View of Pier 1, Looking Southwest.

- (A) Remove the heavy accumulations of timber debris around Piers 1 and 2 to alleviate further degradation of the channel bottom and undermining of the piers.
- (B) Scour rating indicates that bridge has the potential to be at greater risk for scour with further scour analysis required. At a minimum, it is recommended that riprap be properly designed and placed around the piers and in the scour/undermining areas to armor against further scour, unless further scour analysis indicated differently.
- (C) Reinspect the submerged substructure units at the normal maximum recommended (NBIS) interval of five (5) years.

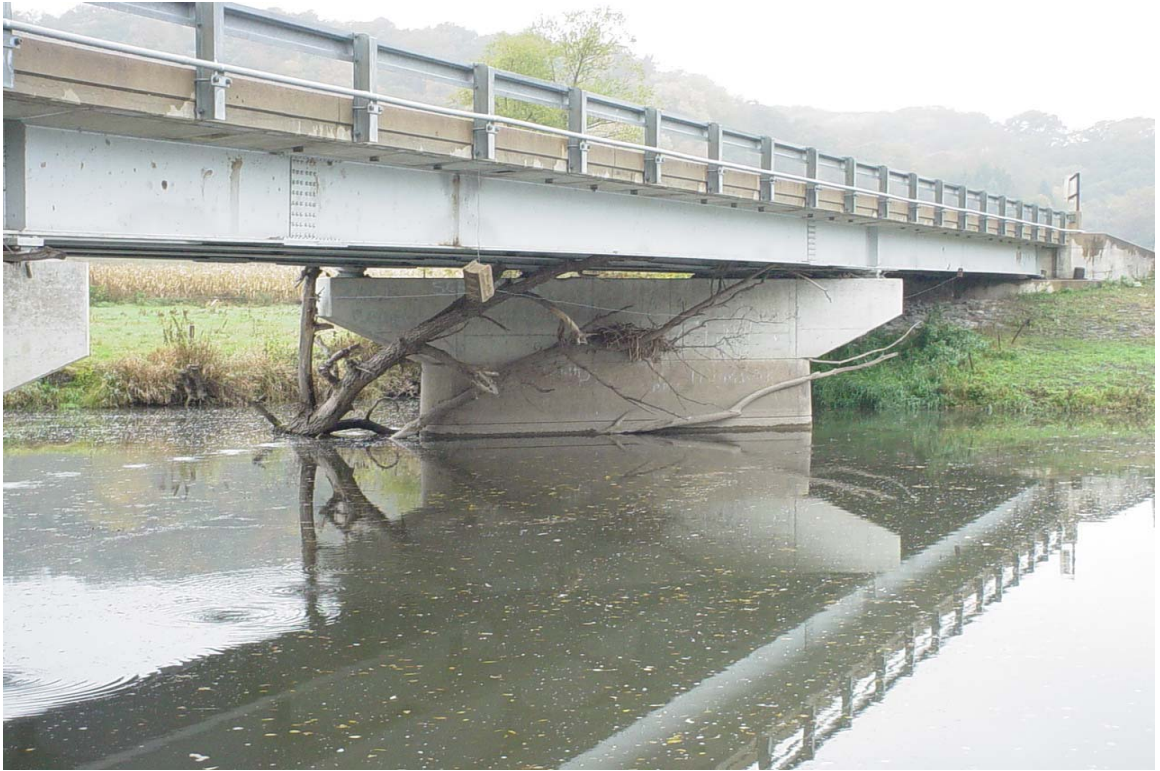
- (B) A moderate accumulation of 2-foot-diameter-and-smaller timber debris was observed extending from the channel bottom to the top of the pier cap at the upstream end and along both faces of Pier 2.

- (C) The footing was exposed at Pier 2 with undermining and exposed steel H-piles observed from the midpoint along the east face, around the upstream end, and extending to the downstream end with a maximum height of 4 feet at the upstream nose.

- (D) Two vertical hairline cracks were observed at the midpoint of Pier 2 that extended from the top of the pier cap to 2 feet below the waterline on the east face and to the channel bottom on the west face.

Photograph 3. View of Pier 2, Looking Southwest.
